Yancey Fuel Solutions Tank Audit

Inspection Number:	1000001	Make:	CATERPILLAR
Equipment Family:	ENGINE - GENERATOR SET	Model:	AST
Asset ID:	Data 8k AST	Inspector:	Jared Robbins
Serial Number:	0000001	Completed On:	08/09/2018 08:08:43 PM
SMU:	1 Cycles	Customer No:	017412
Customer Name:	Sample Customer	Work Order:	E644733
Location:	6 Sample Drive, Sample, Georgia	Coordinates:

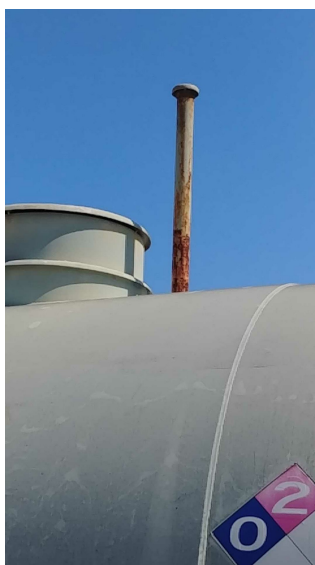
2.2 Tank Vents Clear?

→ Vent riser has is rusting. Recommend repainting.

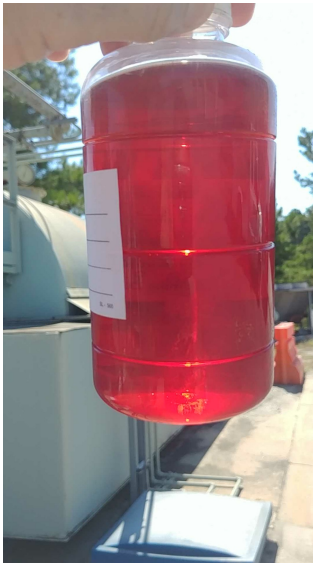
3.1 Fuel Lab Analysis?

→ Fuel smells old and has visible particulate in sample with heavy sediment layer. May require cleaning if lab sample comes back flagged.
